TEST REPORT NO. LZP05-06097/18/R03NZP

Product name: **Aluminum profile wall, without mullions, in the SILENCE EI30 system by VITRINTEC, filled with Contraflam Structure 30 glass made by Vetrotech Saint-Gobain**

Fire resistance tests of non-load-bearing elements
Part 1: Walls.

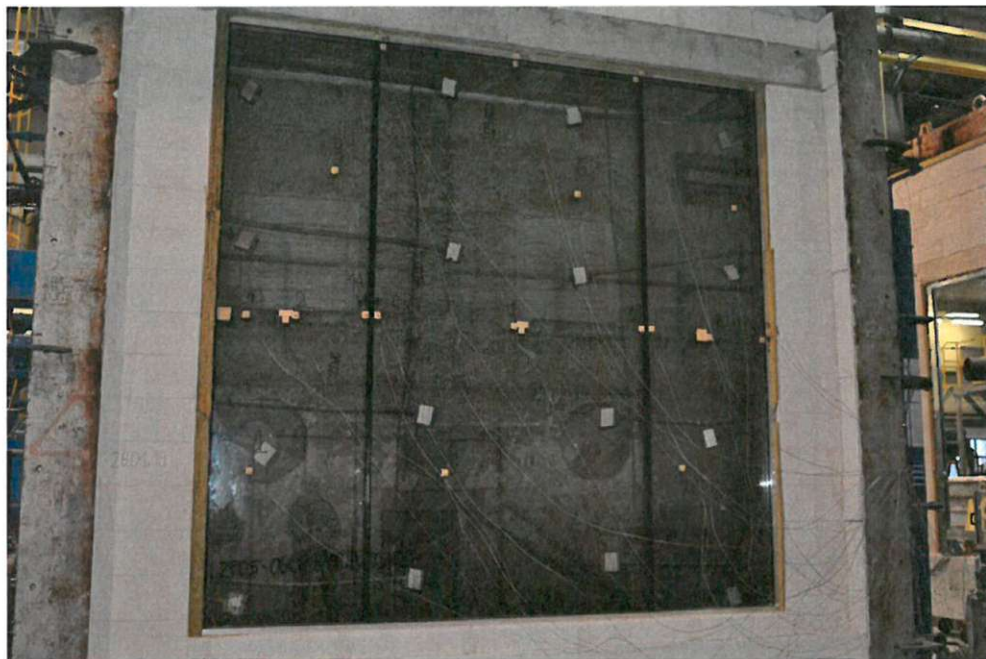
Photo 1. View of the non-heated surface of the test element before testing

The view of the wall before the test is illustrated in Photo 1, during the test in Photo 2 ÷ 5 and after the test in Photo 6 in Appendix No. 3.

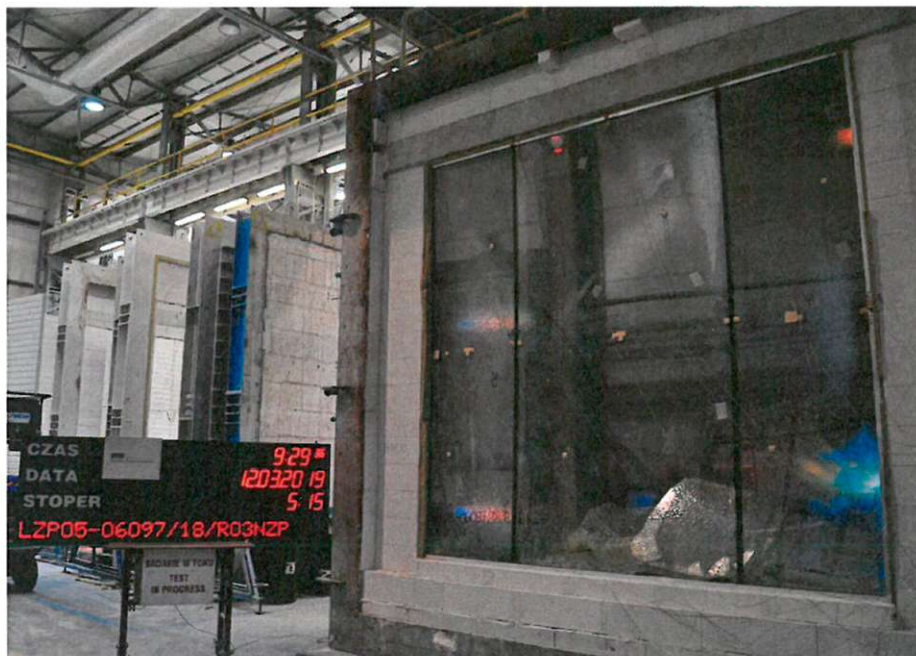
Photo 2. View of the non-heated surface of the test element at 6 minutes of testing

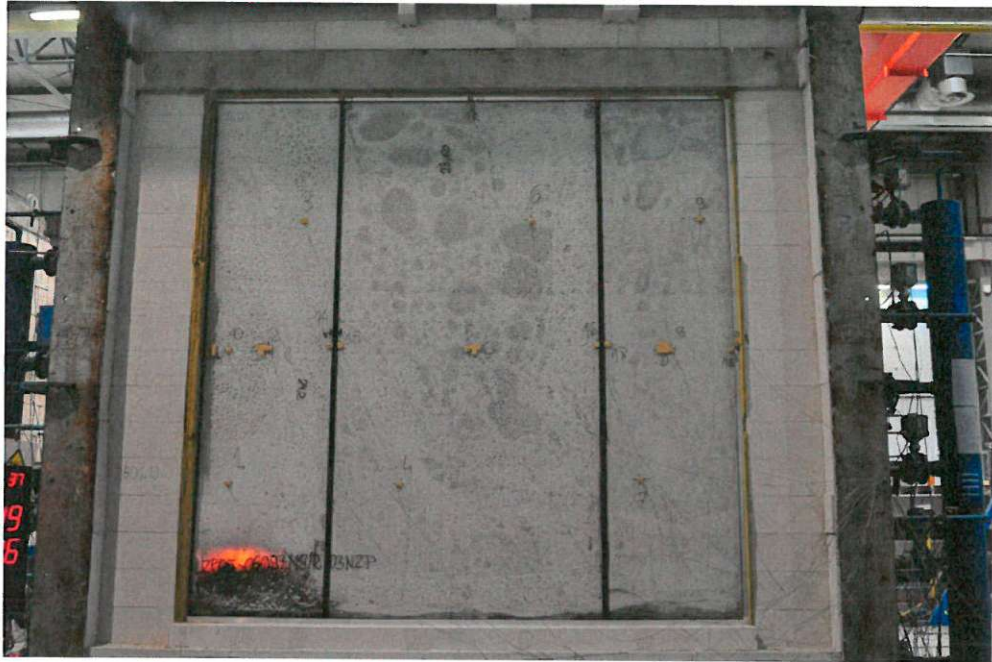
Photo 3. View of the non-heated surface of the test element at 11 minutes of the test

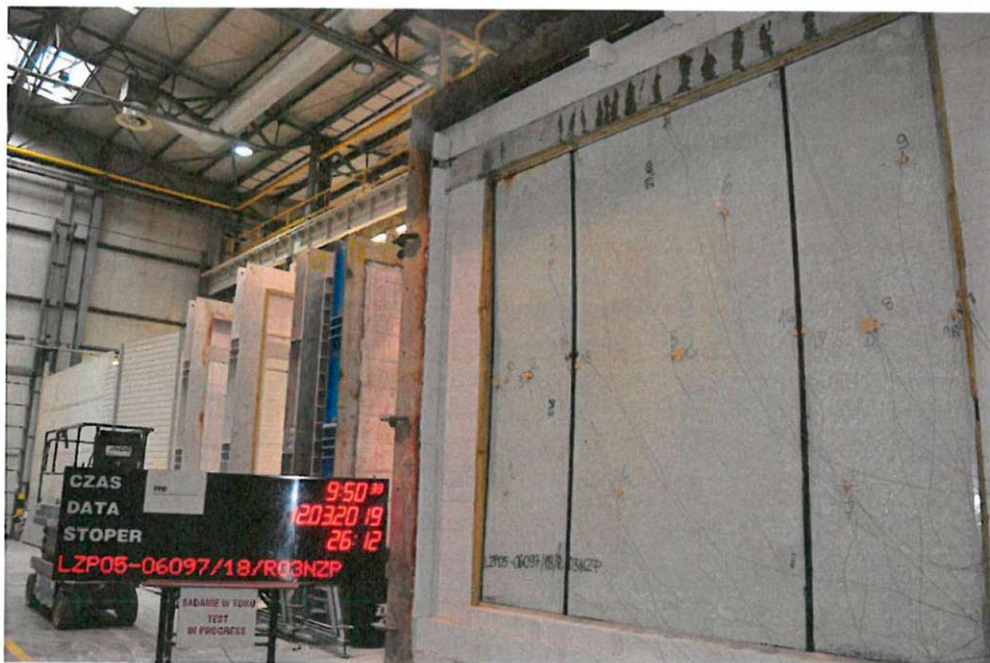
Photo 2. View of the non-heated surface of the test element at 27 minutes of testing

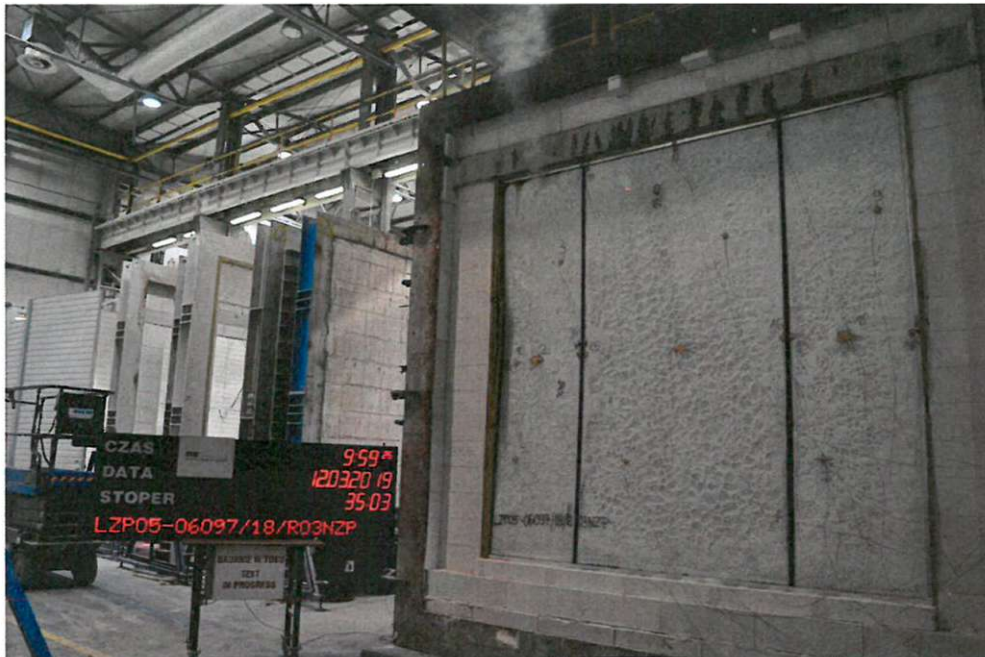
Photo 5. View of the non-heated surface of the test element at 36 minutes of the test

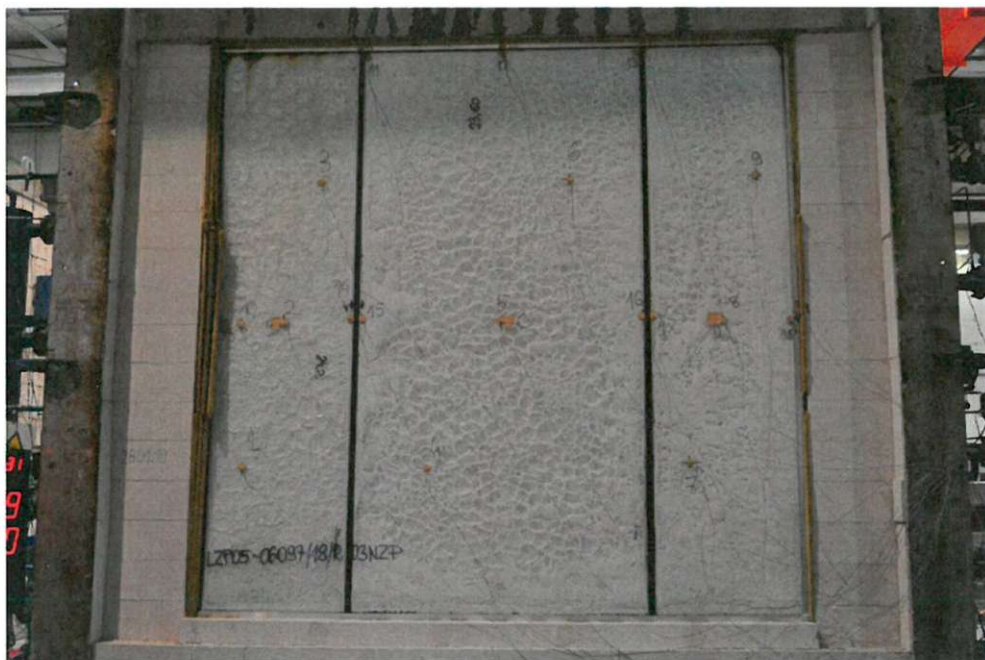
Photo 6. View of the non-heated surface of the test element after testing
